# NARRABRI MINE 2024 ANNUAL REVIEW

| Name of Operation | Narrabri Mine |
| Name of Operator | Narrabri Coal Operations Pty Ltd |

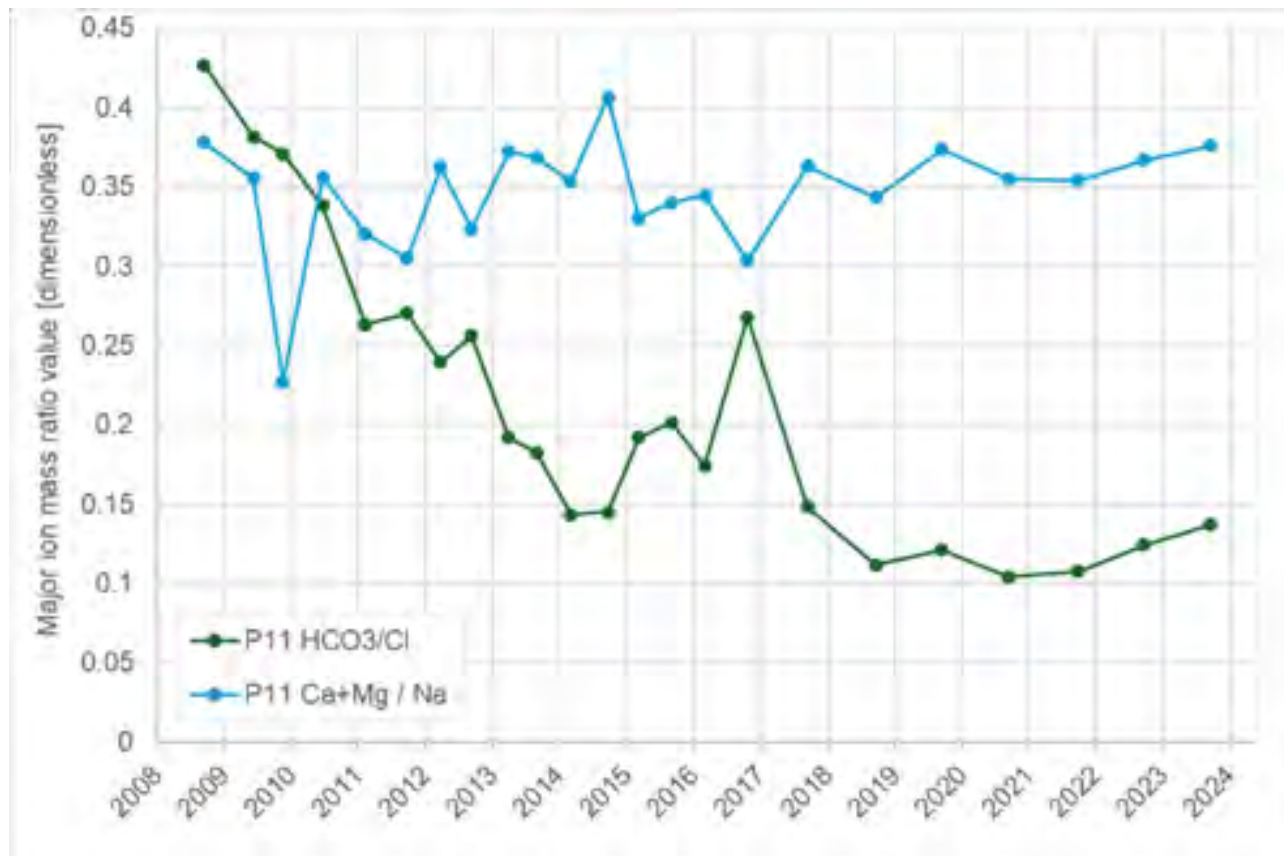
Figure 7.21 Ratios of bicarbonate to chloride and calcium + magnesium to sodium bore P11

Chemical composition of solutes at P11 indicates a sodium-chloride type water, which is similar to bores P9 (Purlawaugh), P2 (Napperby), and P10 (Napperby). As with bore P10, the  $\text{HCO}_3/\text{Cl}$  mass ratio at P11 (Figure 7.21) decreases over time, indicating a change in overall chemistry and likely mixing with water more strongly dominated by chloride. Therefore, lateral migration of groundwater from adjacent areas of the Purlawargh Formation is a possible cause of the EC change.

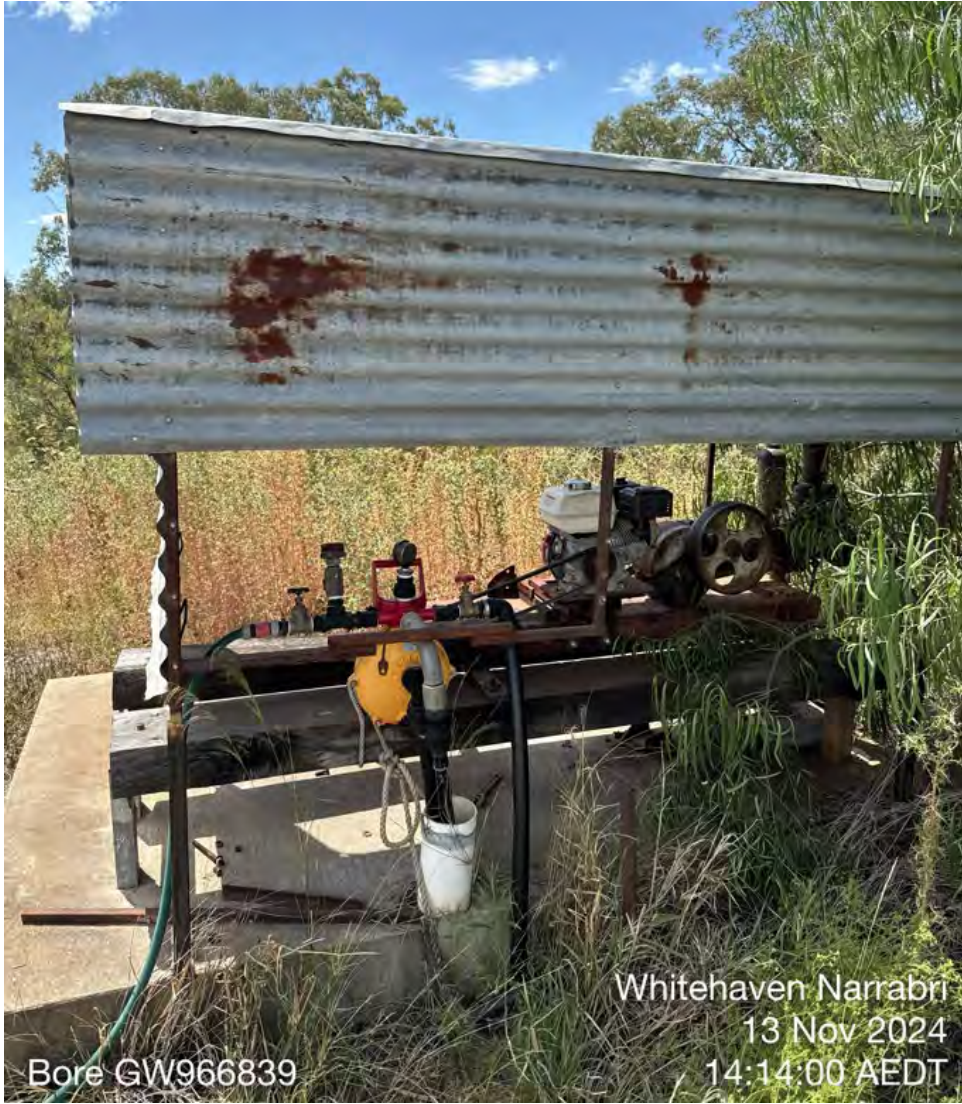
| GW060976 | IMAGE |
|---|---|
| Field notes: The bore is situated in alluvium, 13 meters from the creek. It has not been in use for the past 14 years. The SWL on 13/11/2024 was recorded at 2.34 mbgl. | |

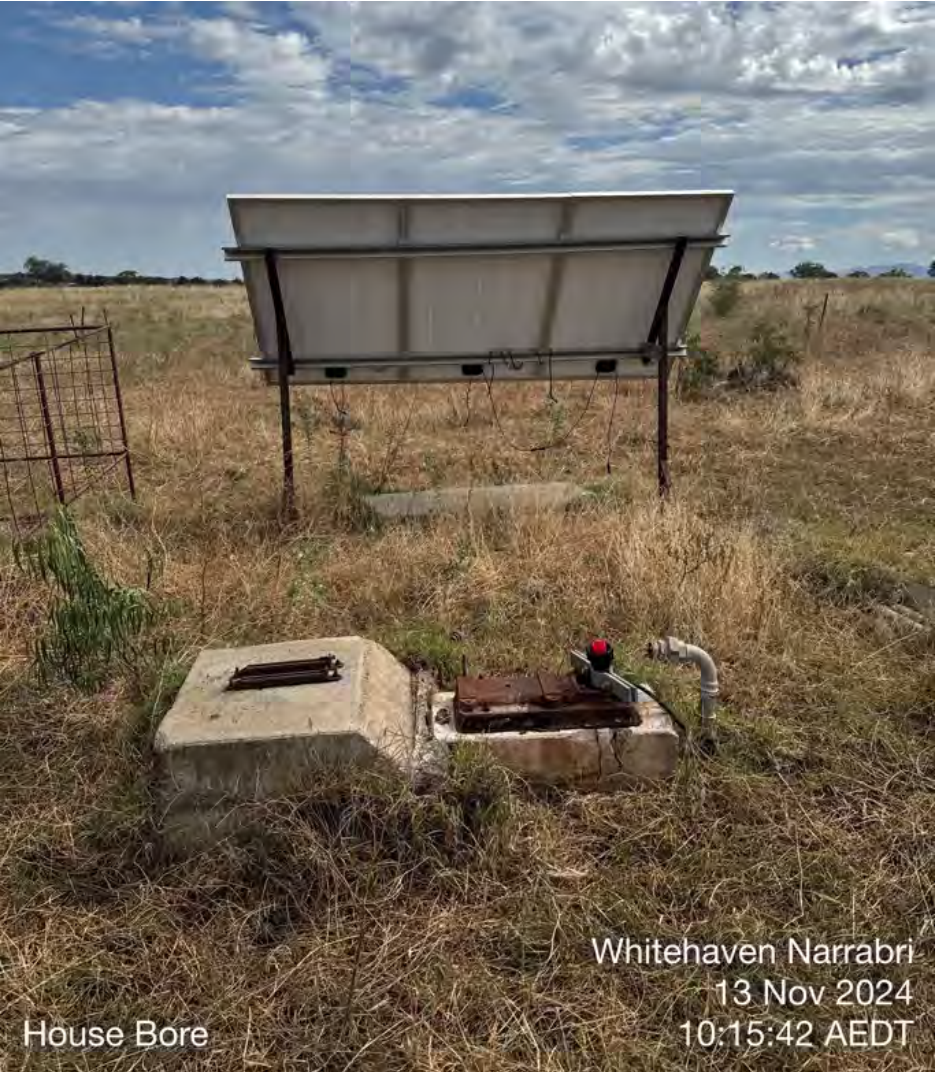
| House Bore | IMAGE |

Field notes: Bore has not been in use for at least the past 5 years. Bore has approximately 27 to 28 meters and it was dry on 13/11/2024.

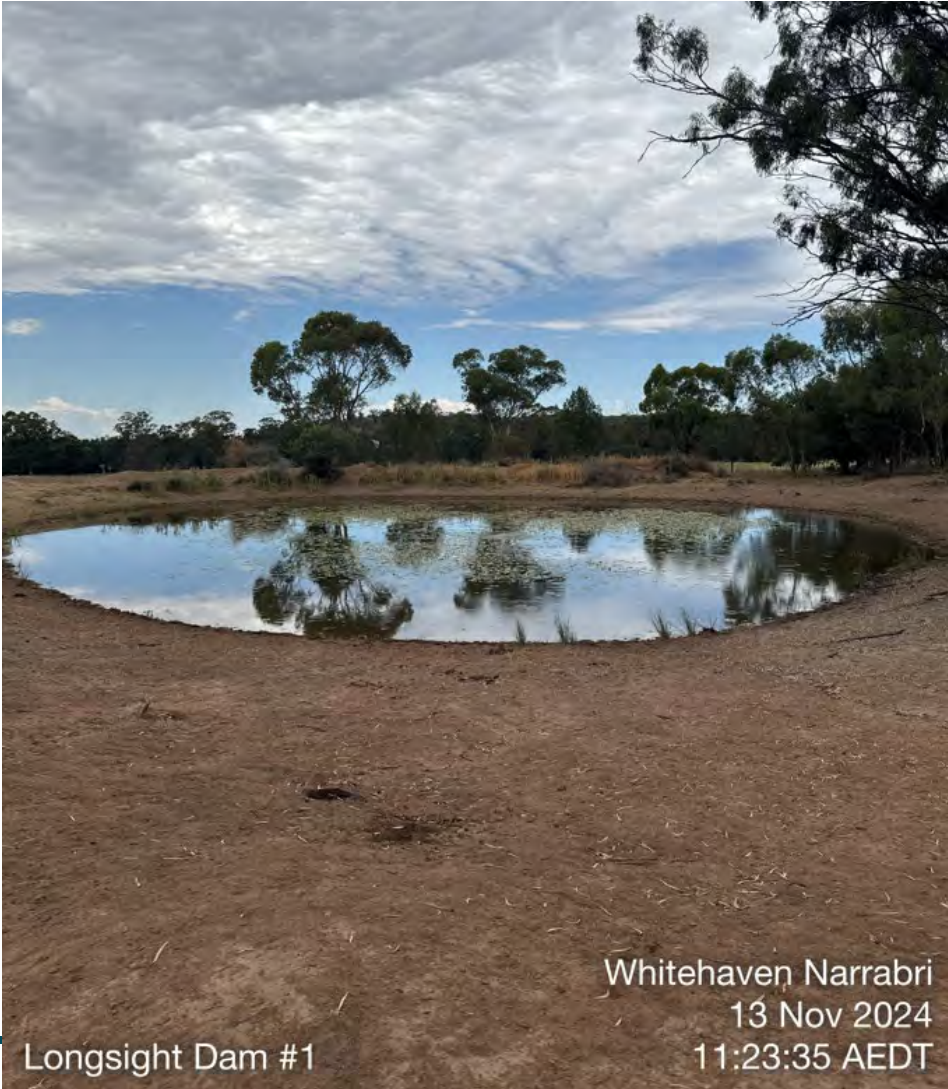
| Longsight Dam #1 | IMAGE |

Field notes: Not a groundwater feature. The water is turbid with algae present. The primary composition is sand with a small amount of gravel. No odor or seepage was observed.

| <b>BORE ID</b> | <b>EASTING*</b> | <b>NORTHING*</b> | <b>PROPERTY</b> | <b>STATUS</b> | <b>COMMENTS</b> |
|---|---|---|---|---|---|
| Longsight Dam #1 | 774353 | 6613824 | Longsight | Stock use | Not a groundwater feature. The water is turbid with algae present. The primary composition is sand with a small amount of gravel. No odor or seepage was observed. |

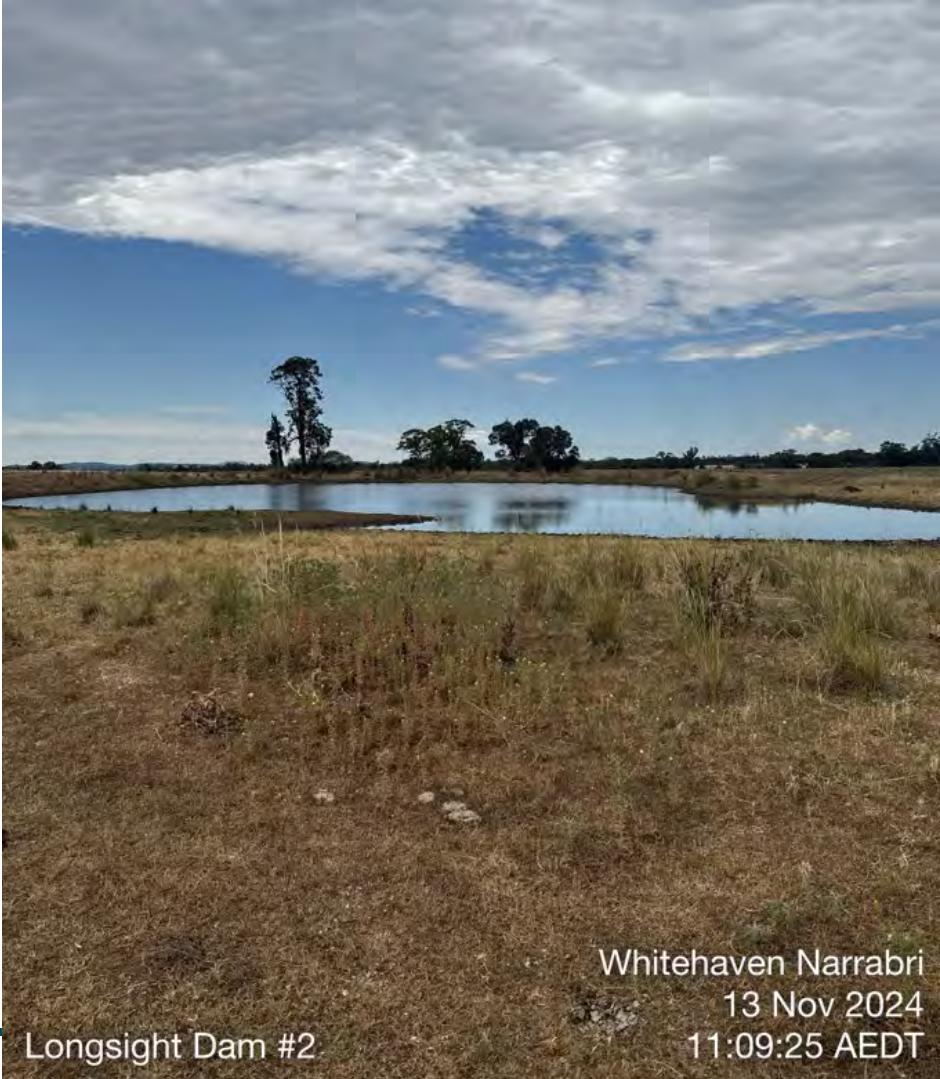
| Longsight Dam #2 | IMAGE |

Field notes: Not a groundwater feature. The water is turbid with algae present. The primary composition is clay and silt. No odor or seepage was observed.

| <i><b>BORE ID</b></i> | <i><b>EASTING*</b></i> | <i><b>NORTHING*</b></i> | <i><b>PROPERTY</b></i> | <i><b>STATUS</b></i> | <i><b>COMMENTS</b></i> |
|---|---|---|---|---|---|
| Longsight Dam #2 | 774916 | 6614015 | Longsight | Stock use | Not a groundwater feature. The water is turbid with algae present. The primary composition is clay and silt. No odor or seepage was observed. |

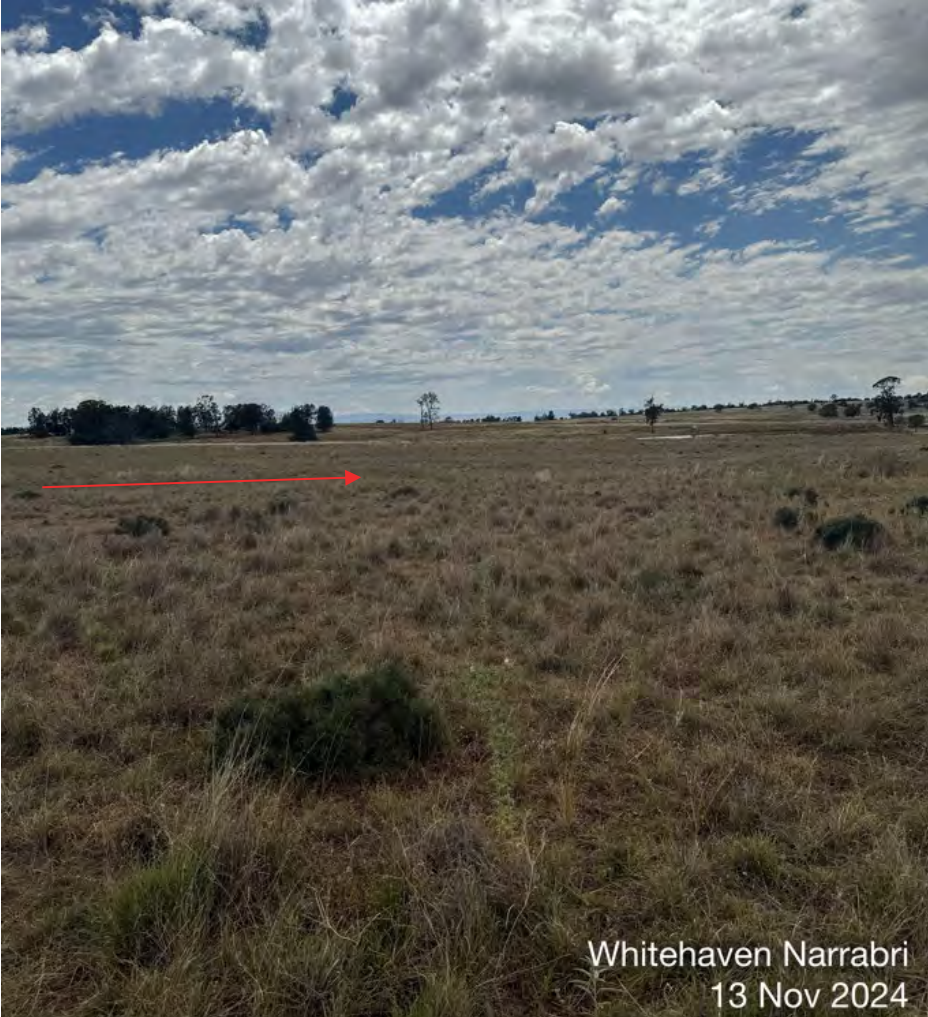
| Mayfield Feature 1 | IMAGE |

Field notes: Not a groundwater feature. It is a small natural drainage channel that is dammed at both ends by Longsight Dam #1 and #2. No water flow observed.

| <i><b>BORE ID</b></i> | <i><b>EASTING*</b></i> | <i><b>NORTHING*</b></i> | <i><b>PROPERTY</b></i> | <i><b>STATUS</b></i> | <i><b>COMMENTS</b></i> |
|---|---|---|---|---|---|
| Mayfield Feature 1 | 774630 | 6613917 | Longsight | NA | Not a groundwater feature. It is a small natural drainage channel that is dammed at both ends by Longsight Dam #1 and #2. No water flow observed. |

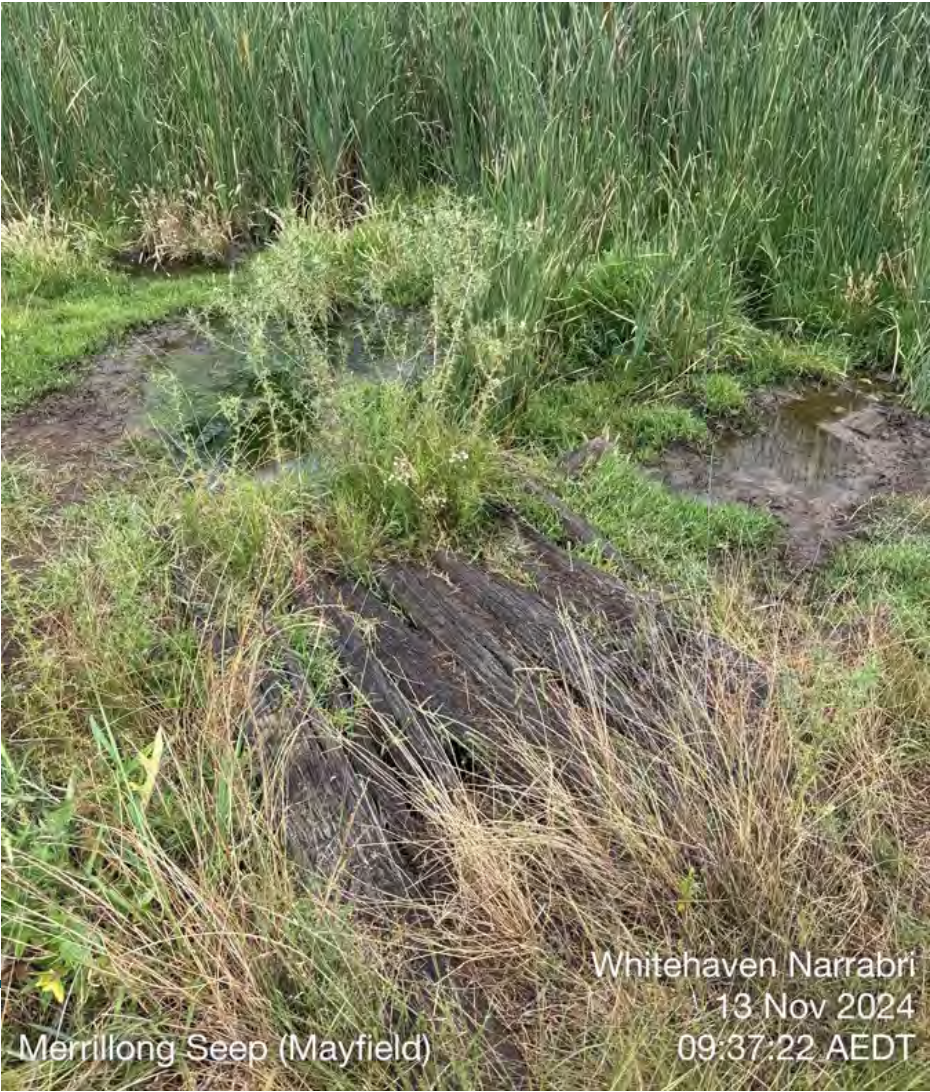
| Merrilong Seep | IMAGE |

Field notes: Not a groundwater feature. A square wooden "well head" was constructed to harness the seep. The primary composition observed was silt and sand. The water level was recorded at the surface on 13/14/2024.

| <i><b>BORE ID</b></i> | <i><b>EASTING*</b></i> | <i><b>NORTHING*</b></i> | <i><b>PROPERTY</b></i> | <i><b>STATUS</b></i> | <i><b>COMMENTS</b></i> |
|---|---|---|---|---|---|
| Merrilong Seep | 775670 | 6615617 | Merrilong | NA | Not a groundwater feature. A square wooden "well head" was constructed to harness the seep. The primary composition observed was silt and sand. The water level was recorded at the surface on 13/14/2024. |

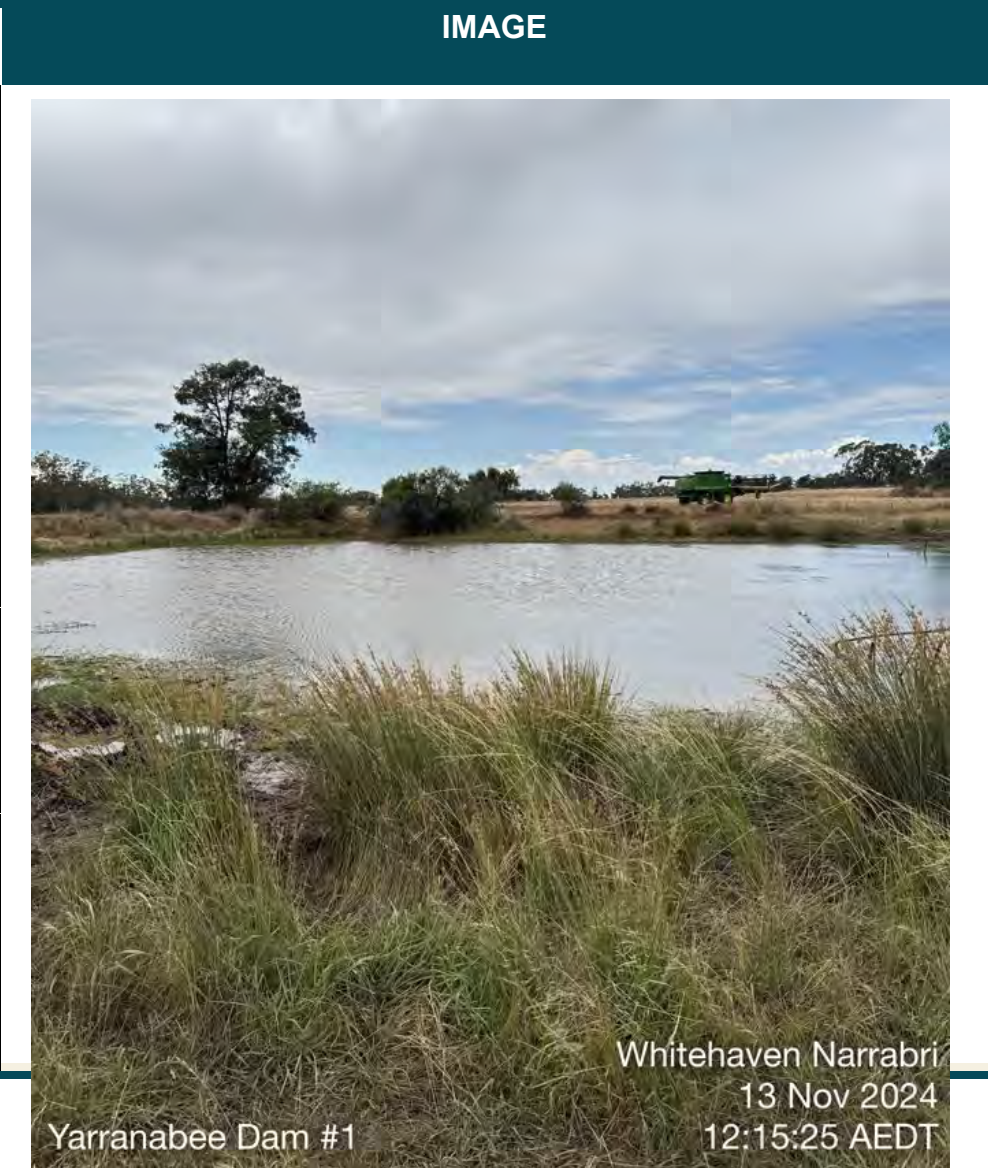
Field notes: Not a groundwater feature. The water is turbid with minimal algae present. The primary composition is silt, sand and gravel. No odor or seepage was observed.

| <i><b>BORE ID</b></i> | <i><b>EASTING*</b></i> | <i><b>NORTHING*</b></i> | <i><b>PROPERTY</b></i> | <i><b>STATUS</b></i> | <i><b>COMMENTS</b></i> |
|---|---|---|---|---|---|
| Yarranabee Dam #1 | 774935 | 6612839 | Yarranabee | Stock use | Not a groundwater feature. The water is turbid with minimal algae present. The primary composition is silt, sand and gravel. No odor or seepage was observed. |

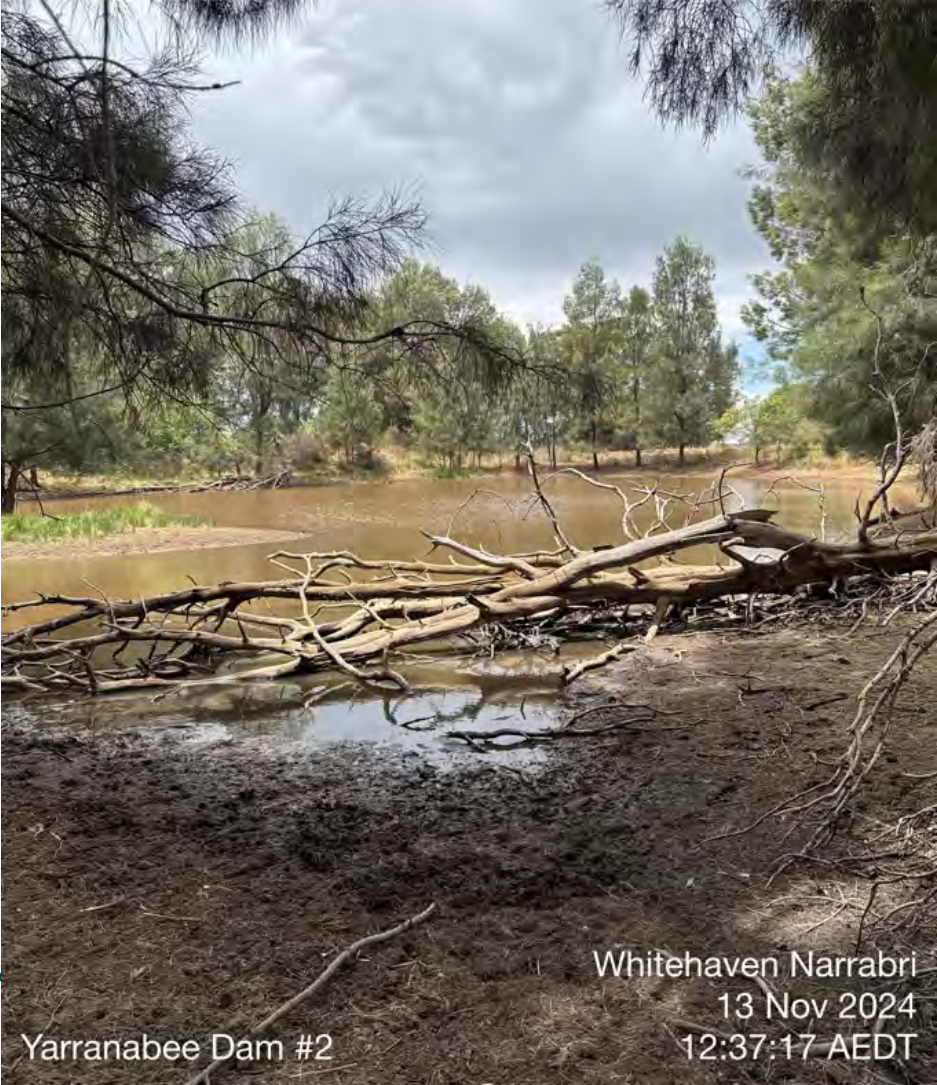
| Yarranabee Dam #2 | IMAGE |

Field Notes: Not a groundwater feature. The water is turbid with minimal algae present. The primary composition is silt, sand and minimal gravel. No odor or seepage was observed.

| <i><b>BORE ID</b></i> | <i><b>EASTING*</b></i> | <i><b>NORTHING*</b></i> | <i><b>PROPERTY</b></i> | <i><b>STATUS</b></i> | <i><b>COMMENTS</b></i> |
|---|---|---|---|---|---|
| Yarranabee Dam #2 | 776014 | 6613131 | Yarranabee | Stock use | Not a groundwater feature. The water is turbid with minimal algae present. The primary composition is silt, sand and minimal gravel. No odor or seepage was observed. |
